Smoke and Dye Testing Summary

High Level Sewershed

Test ID	Test Type	Date Inspected	Company / Super.	Blower MH	Ground Condition	Notification Made?	Total Length
S1028-032	Smoke	8/18/2008	ADS/TM	S13WW_009MH	Dry	Yes	1,779.59

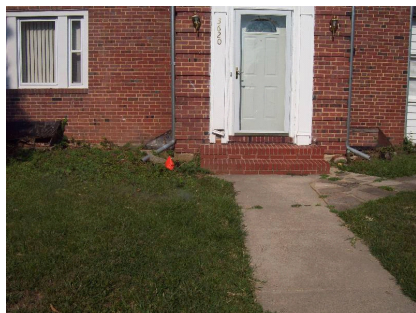
Picture \S1028-032-OB01-P01.jpg

Source Cleanout

Location Yard - front

Comments Smoke from cleanout in front yard. 3620 Wabash Ave.

Comments Front of house, 3620 Wabash Ave.

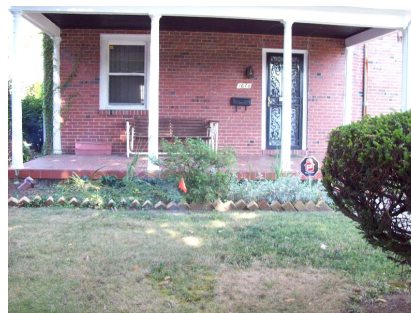
Picture \S1028-032-OB02-P01.jpg

Source Cleanout

Location Yard - front

Comments Smoke from cleanout in front yard. 3618 Wabash Ave.

Comments Front of house, 3618 Wabash Ave.

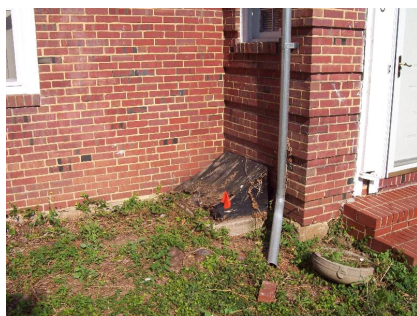
Picture \S1028-032-OB03-P01.jpg

Source Other

Location Yard - front

Comments Smoke near cellar entrance at the front of the house. 3620 Wabash Ave.

Comments Front of house, 3620 Wabash Ave.

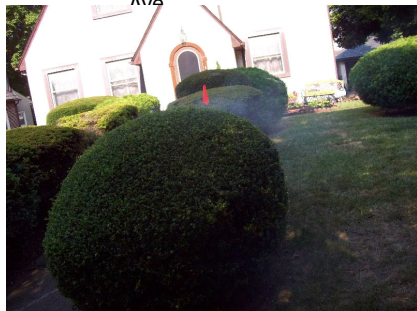
Picture \S1028-032-OB05-P01.jpg

Source Cleanout

Location Yard - front

Comments Smoke from cleanout in front yard behind a bush adjacent to the walkway. 3404 Wabash Ave.

Comments Front of house, 3404 Wabash Ave.

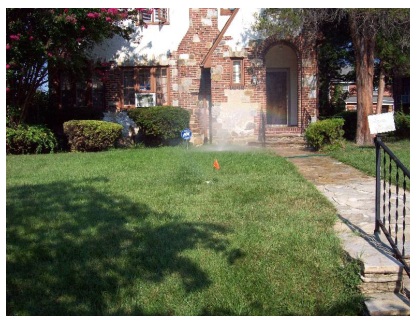
Picture \S1028-032-OB04-P01.jpg

Source Cleanout

Location Yard - front

Comments Smoke from cleanout in front yard. 3410 Wabash Ave.

Comments Front of house, 3410 Wabash Ave.

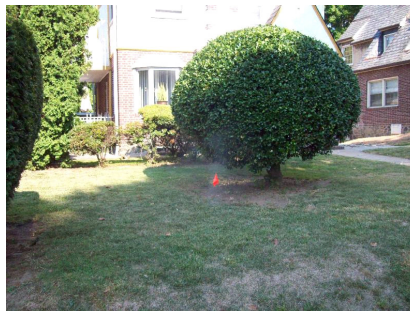
Picture \S1028-032-OB06-P01.jpg

Source Cleanout

Location Yard - front

Comments Smoke from cleanout in front yard. 3400 Wabash Ave.

Comments Front of house, 3400 Wabash Ave.
